STABILIZATION OF MOVING LAND MASSES BY CAST-IN-PLACE PILES

John B. Palmerton

Geotechnical Laboratory

May 1984

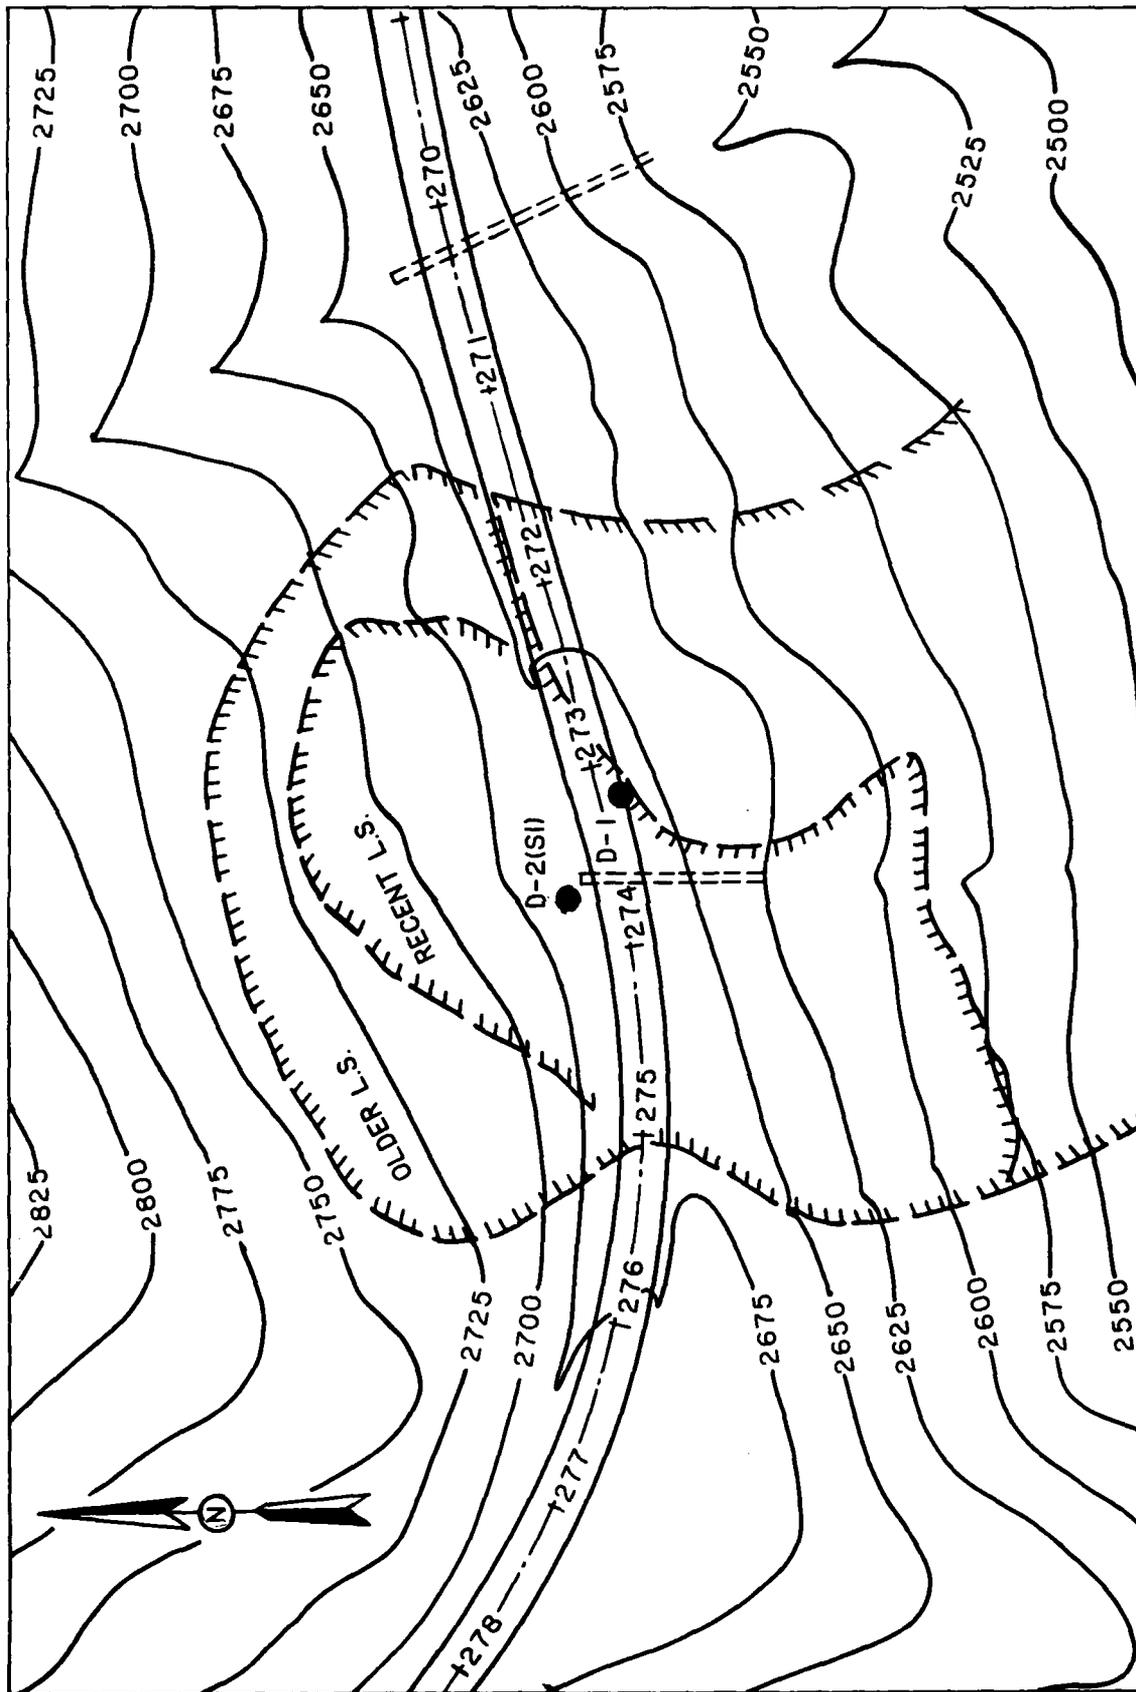
Figure 18. Topography of project site

44. Movement on the downhill side also occurred with subsequent displacements of the roadway and sidehill embankment. Cracking and pushouts of loose material can be observed for a distance of approximately 200 ft downslope (Figure 18).

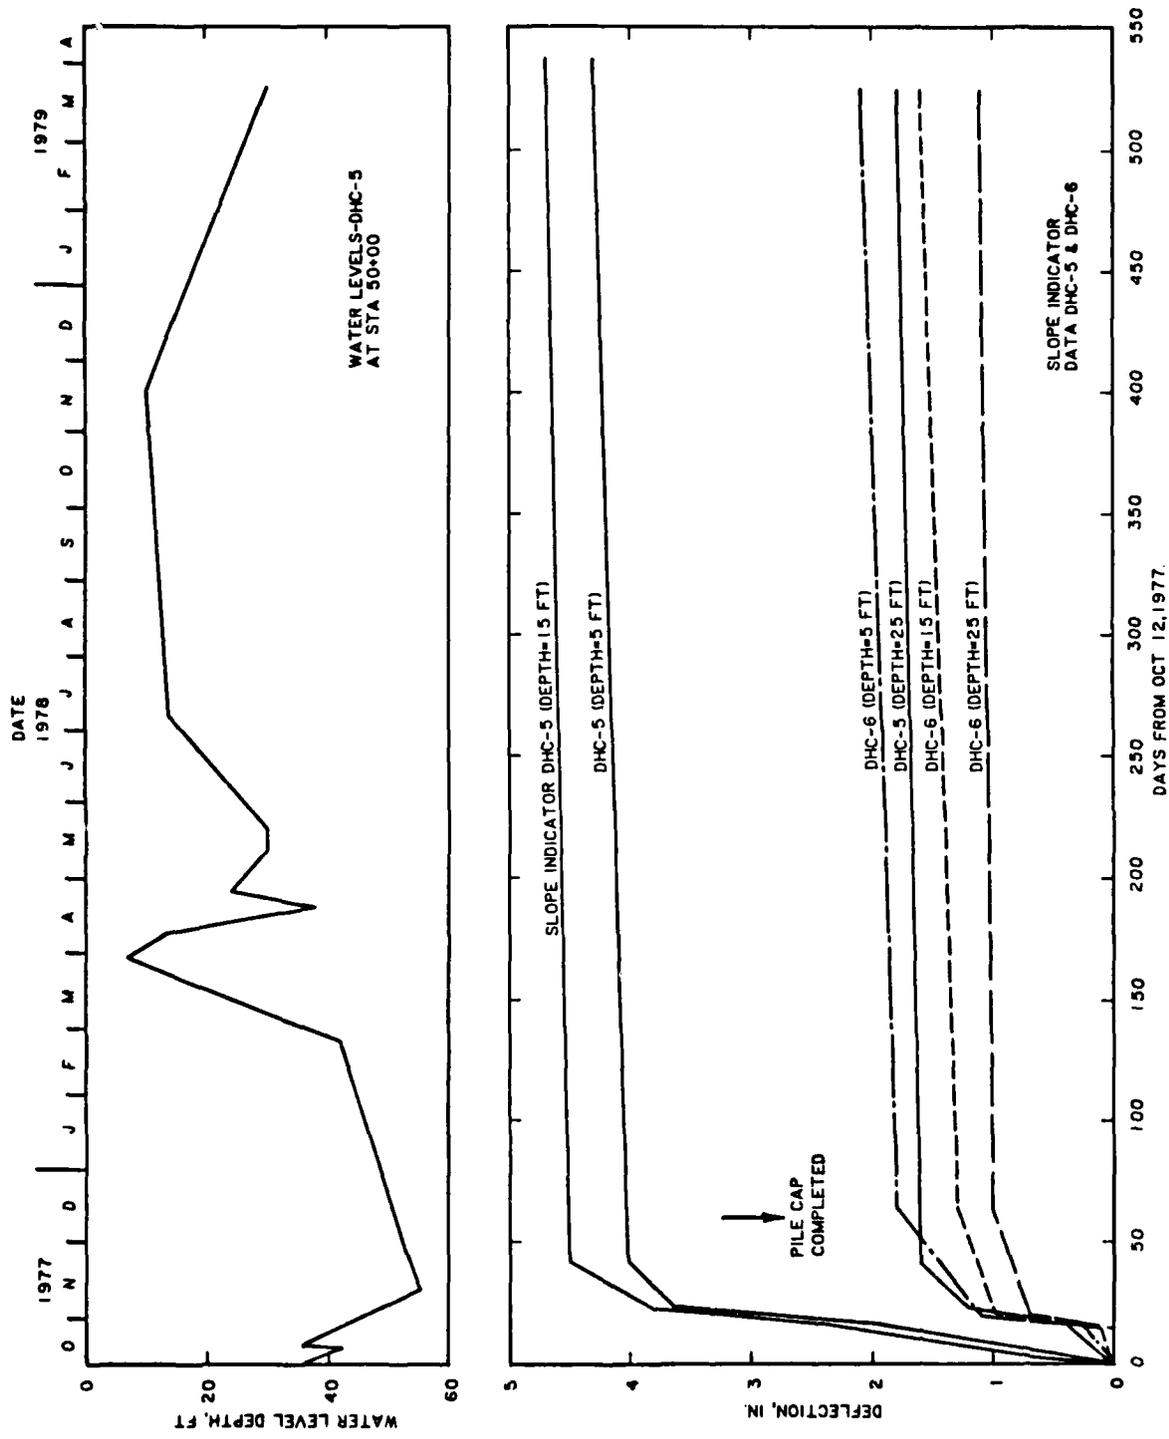
97. The time histories (Figure 98) show that the movements markedly decreased after the installation of the pile cap. This relative lack of movement is also consistent with the decrease in strain gage output following the placement of the pile cap. The water level recordings, also shown in Figure 98, show an increase in water level during the spring (1979) months. However, this increase in water level did not cause an associated landslide movement.

Figure 98. Slope indicator deflections and water level readings
